**HIGHLAND FLATS TREE FARM**  
**WETLAND AND RIPARIAN MITIGATION**  
**-2018 ANNUAL REPORT-**

**December 2018**

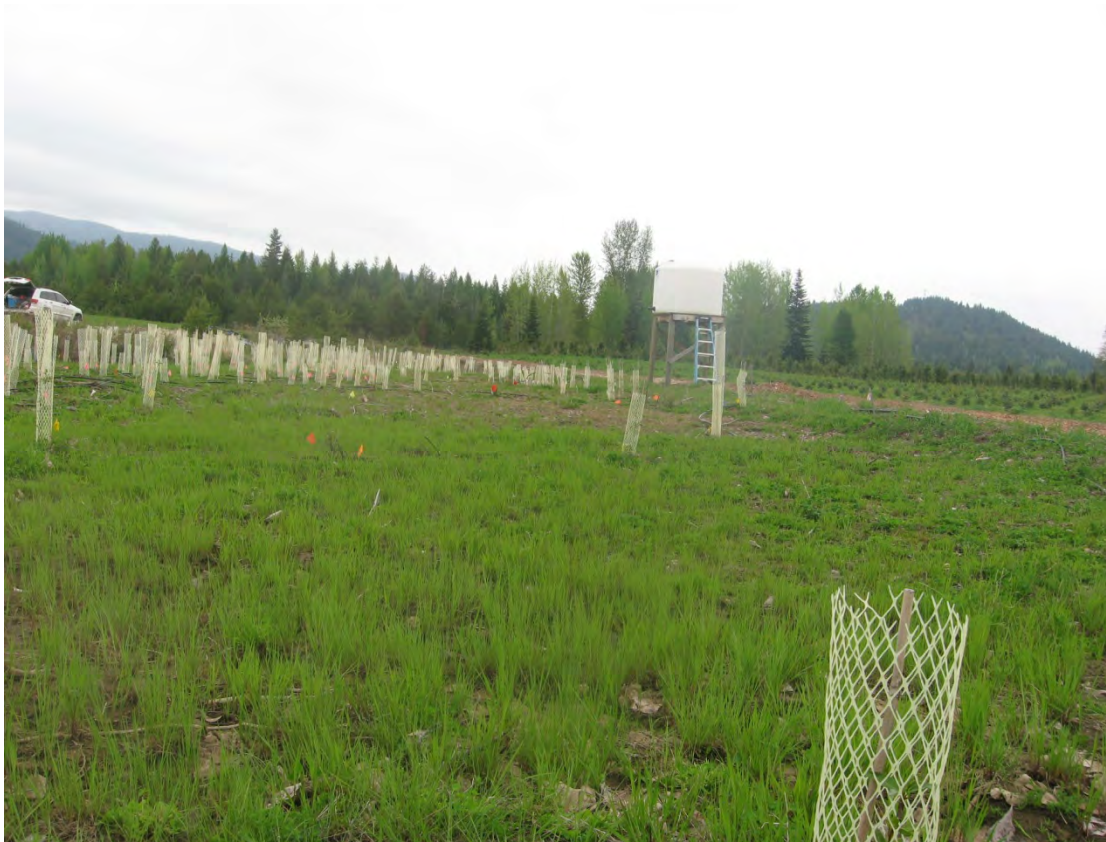
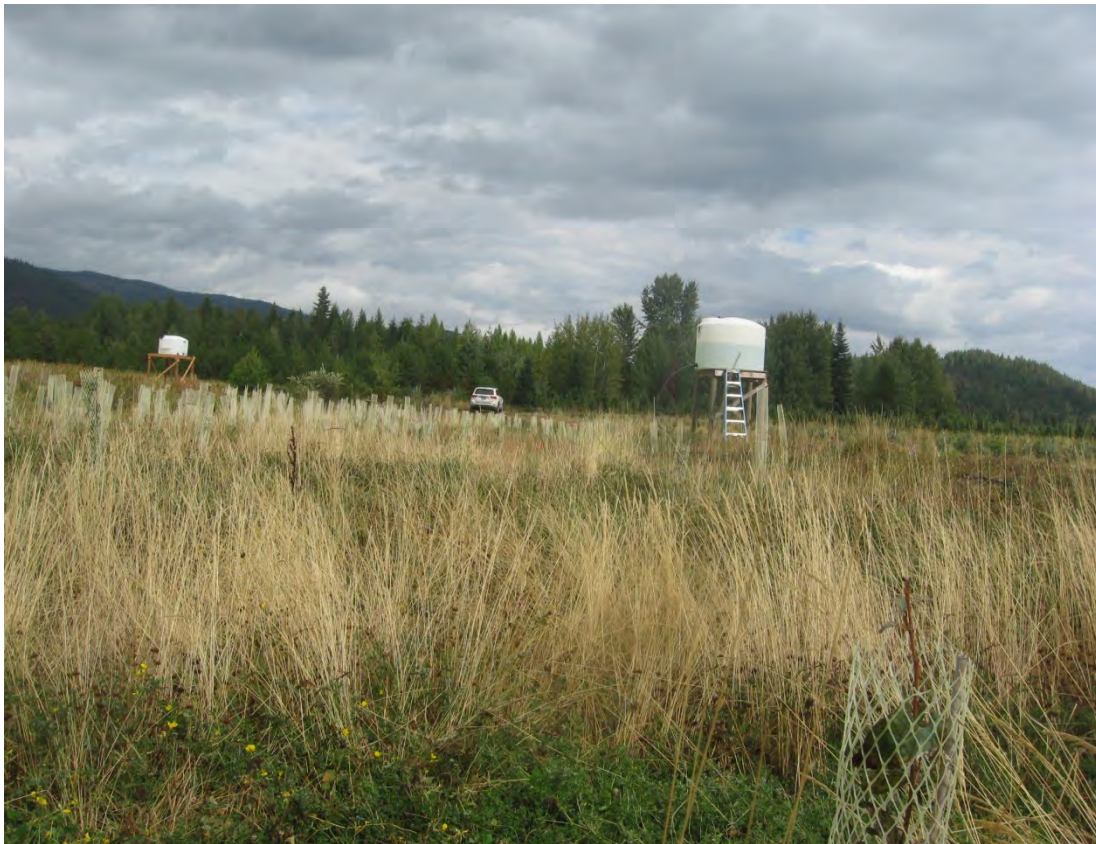
**Figure C-1. Comparison of the new grass growth in HW-2, 2016 graded in spring 2018 (top) to the more patchy fall 2018 grass-clover dominance (bottom).**

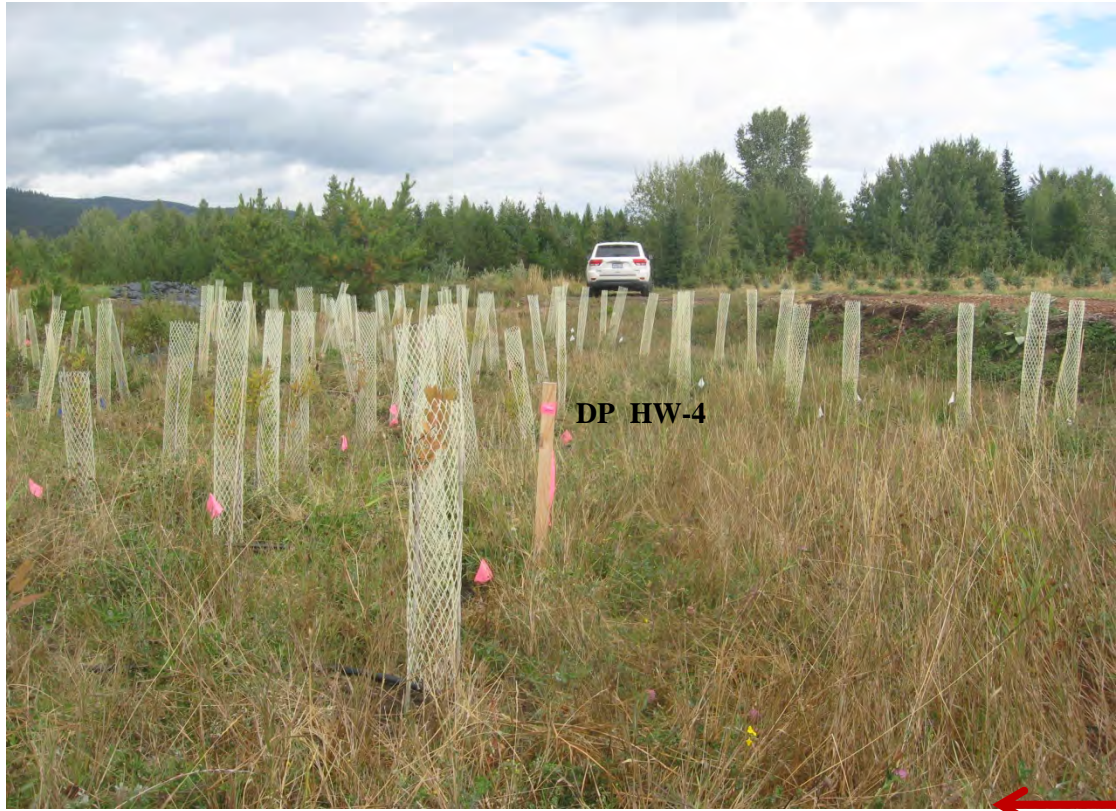
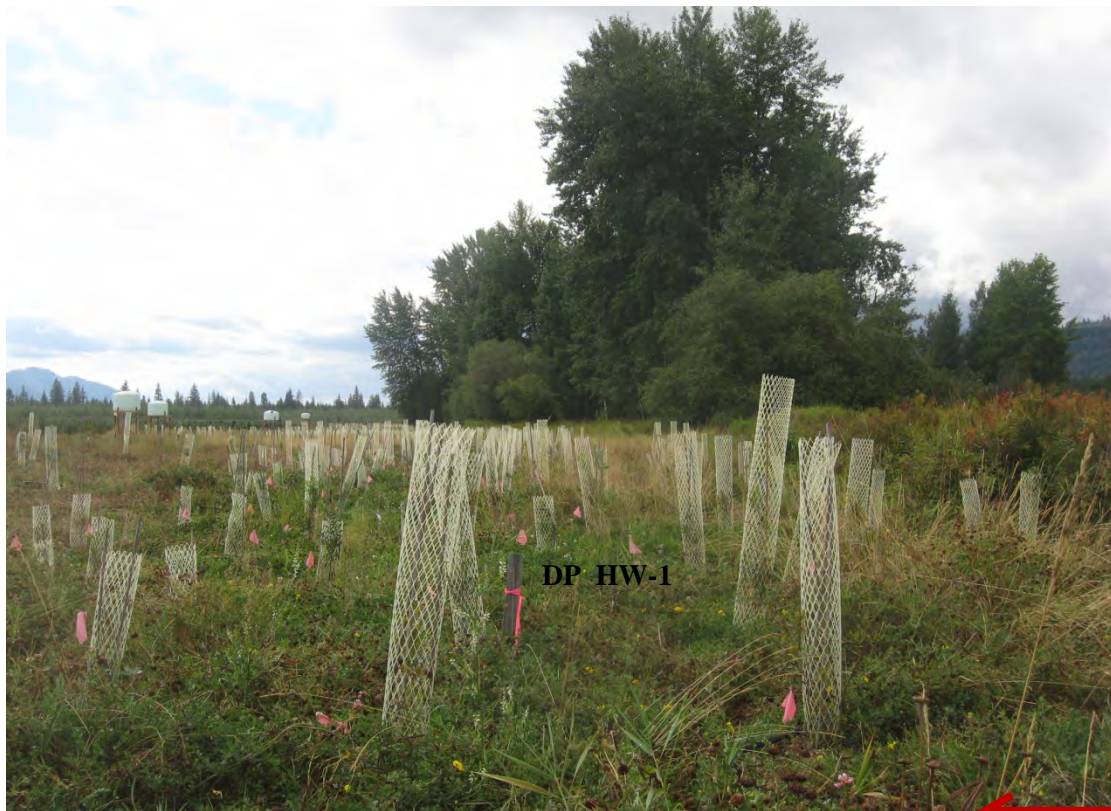
**Transect 2**

**Figure C-2. Transect 2 photopoint looking north at HW-2, 2017 graded (top) and south at HW-2, 2016 graded (bottom).**

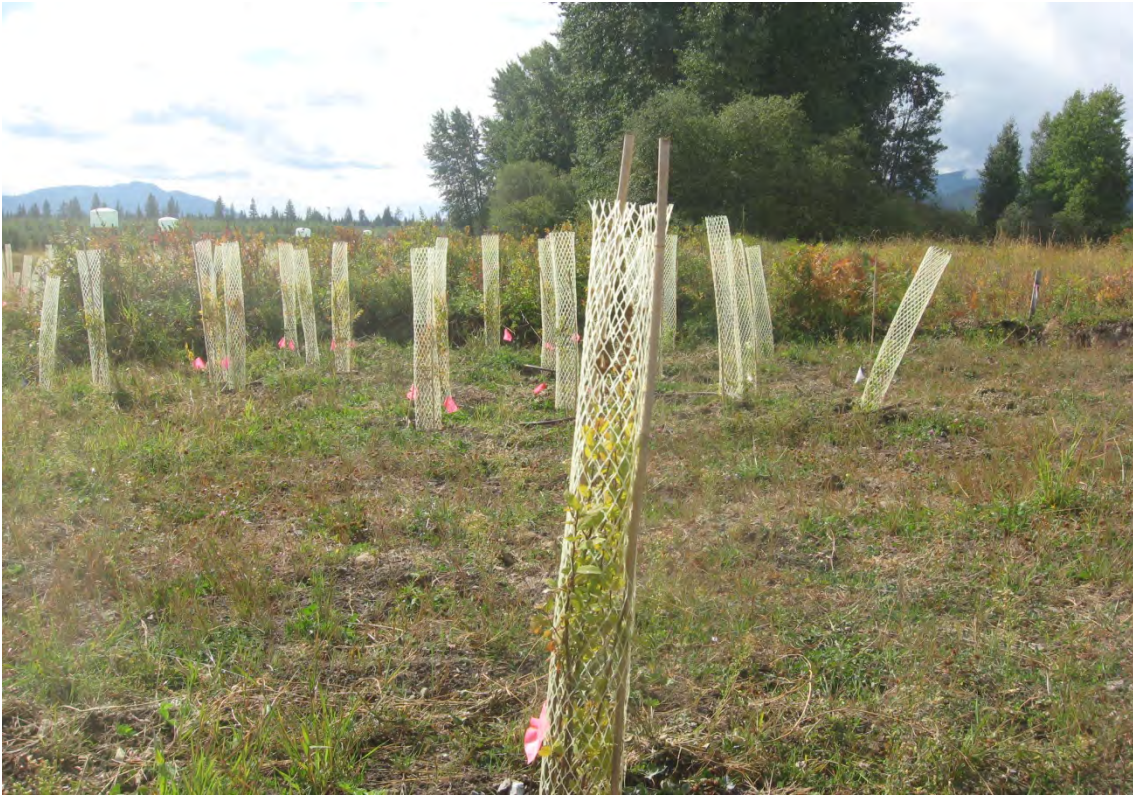
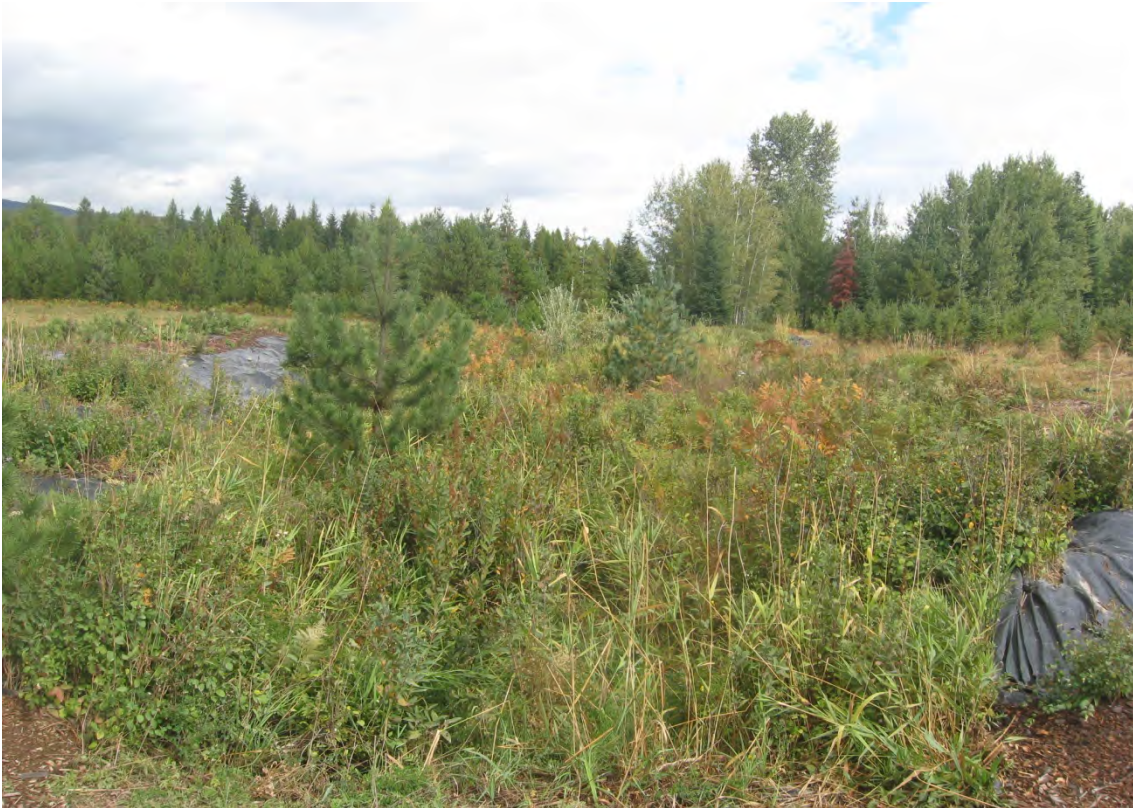
**Figure C-3. HW-2, 2017 graded looking south from DP HW-3 and showing high meadowsweet vigor (top) and looking north at the HW-1 buffer from the farm road in which ongoing maintenance removed plants/prevented RCG and tansy flowering (bottom).**

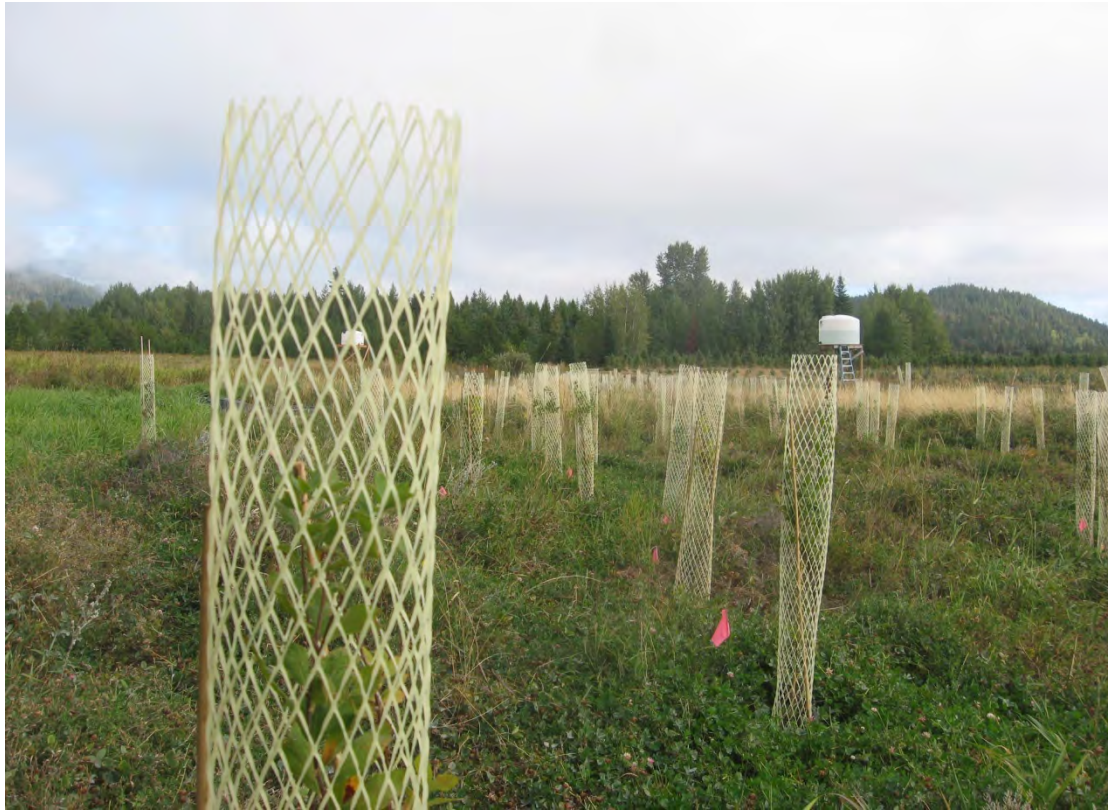
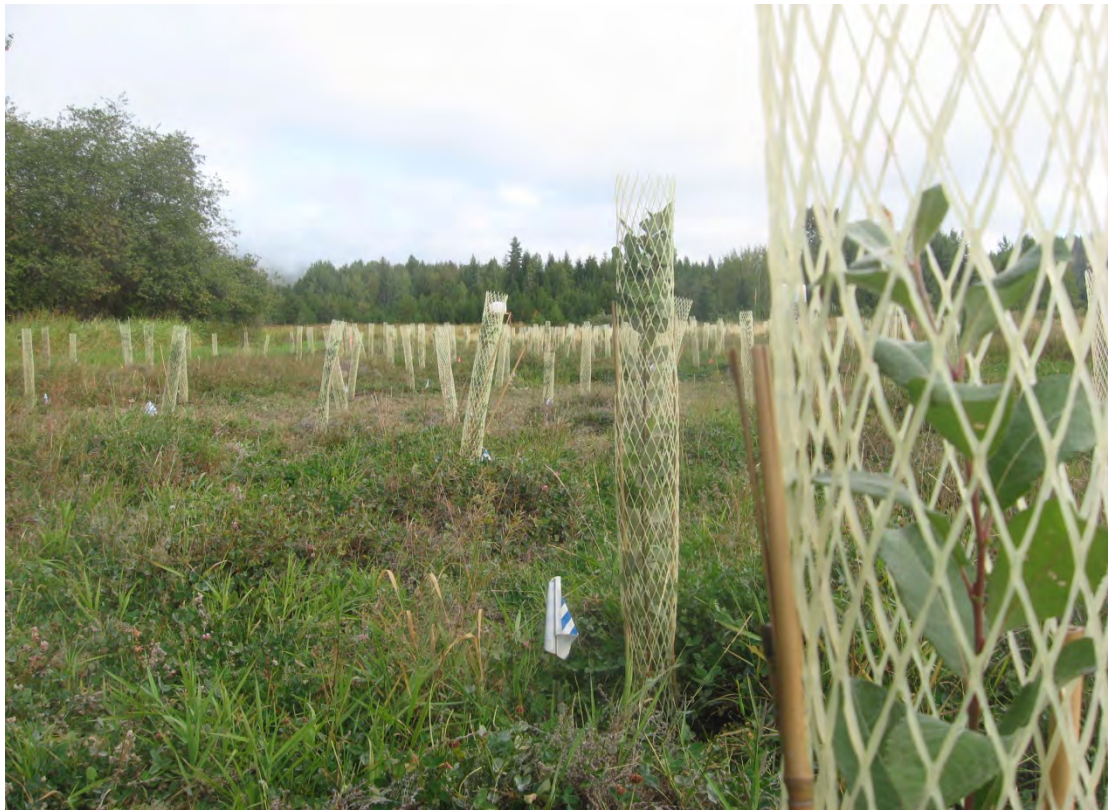
**Figure C-4. HW-3a, looking north from DP HW-5 (top) and DP HW-6 (bottom) in HW-3a depicting high planted shrub vigor but mixed native-trefoil/lotus understory.**

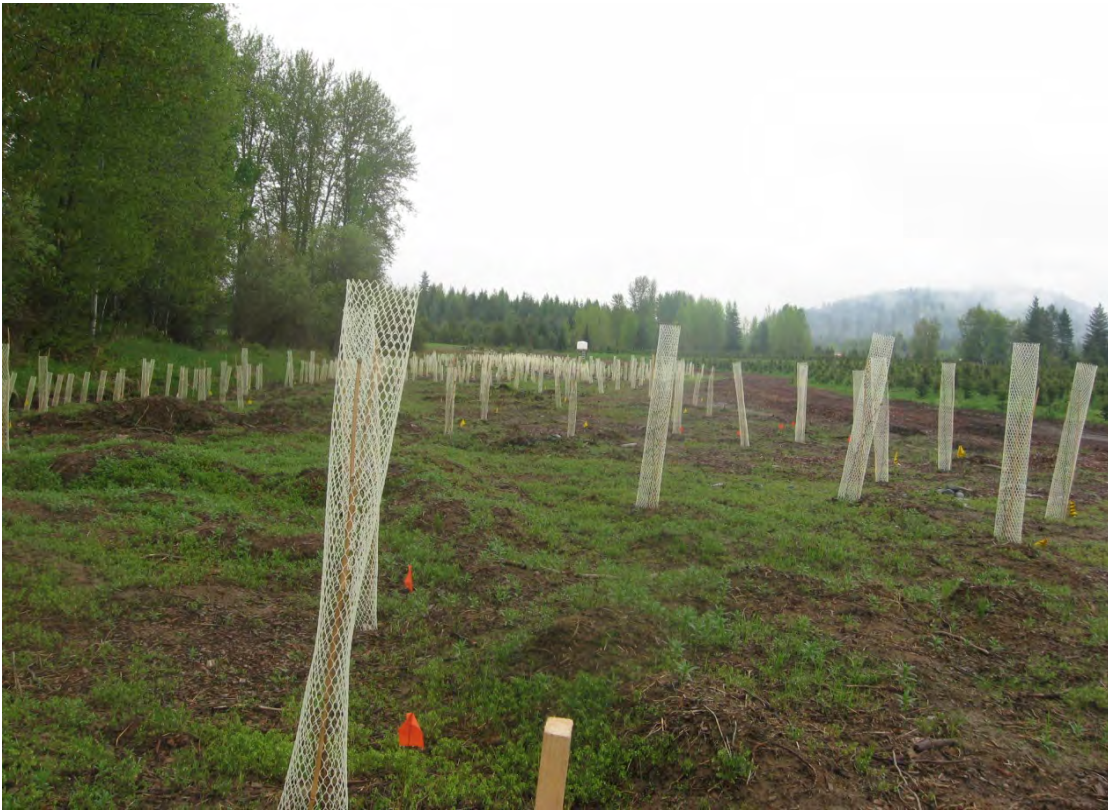
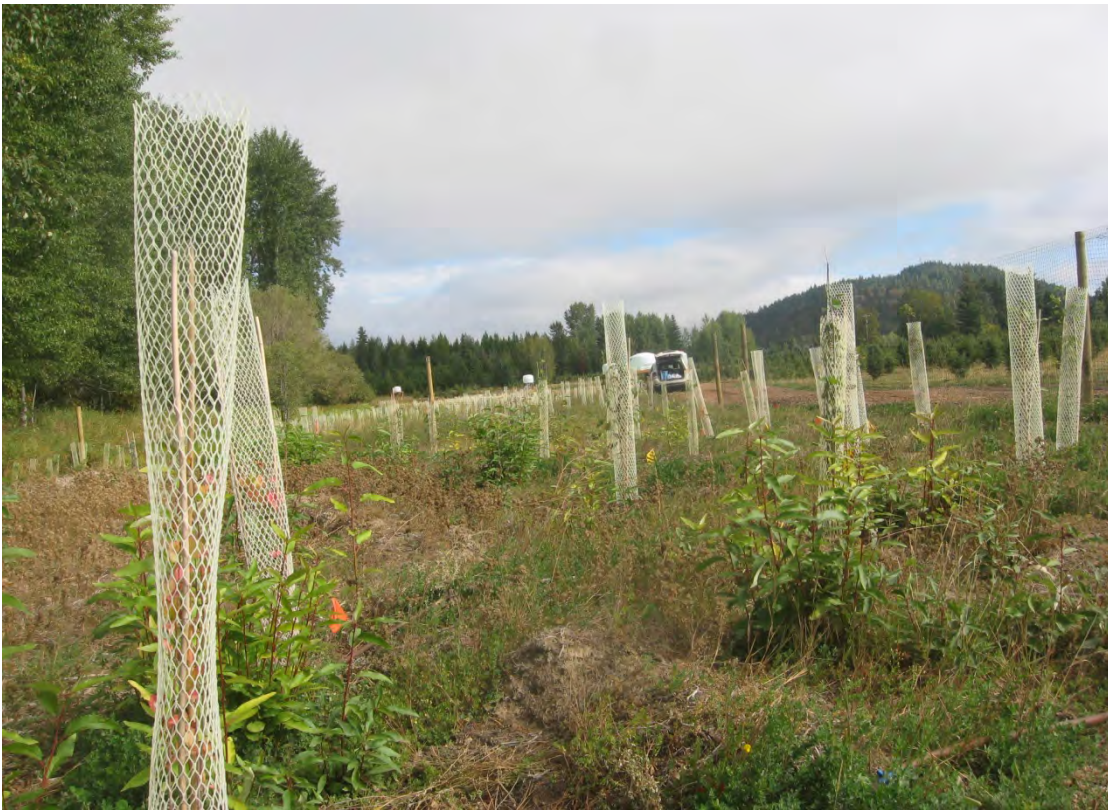
**Figure C-6. Comparison of DP HW-9 in HW-3b looking north in June 2018 when *Montia linearis* was the dominant understory species (top), and in September, post-exclosure construction with volunteer cottonwood growth (bottom).**

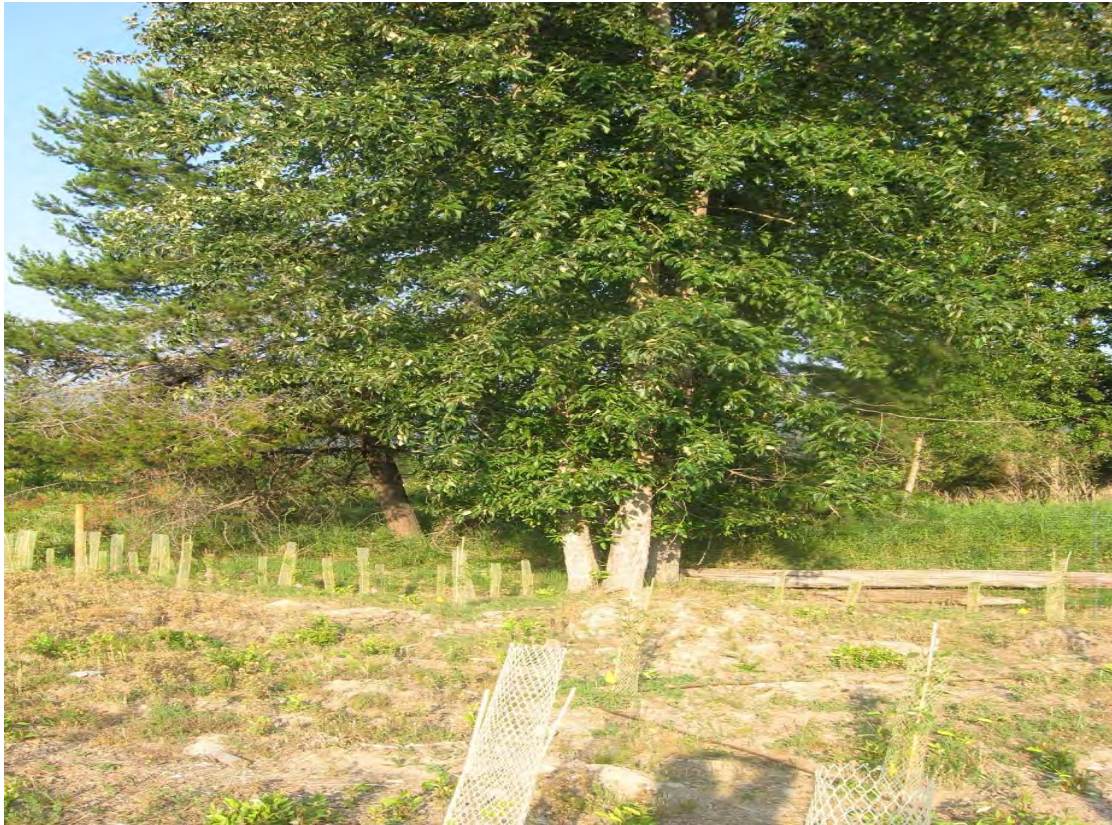
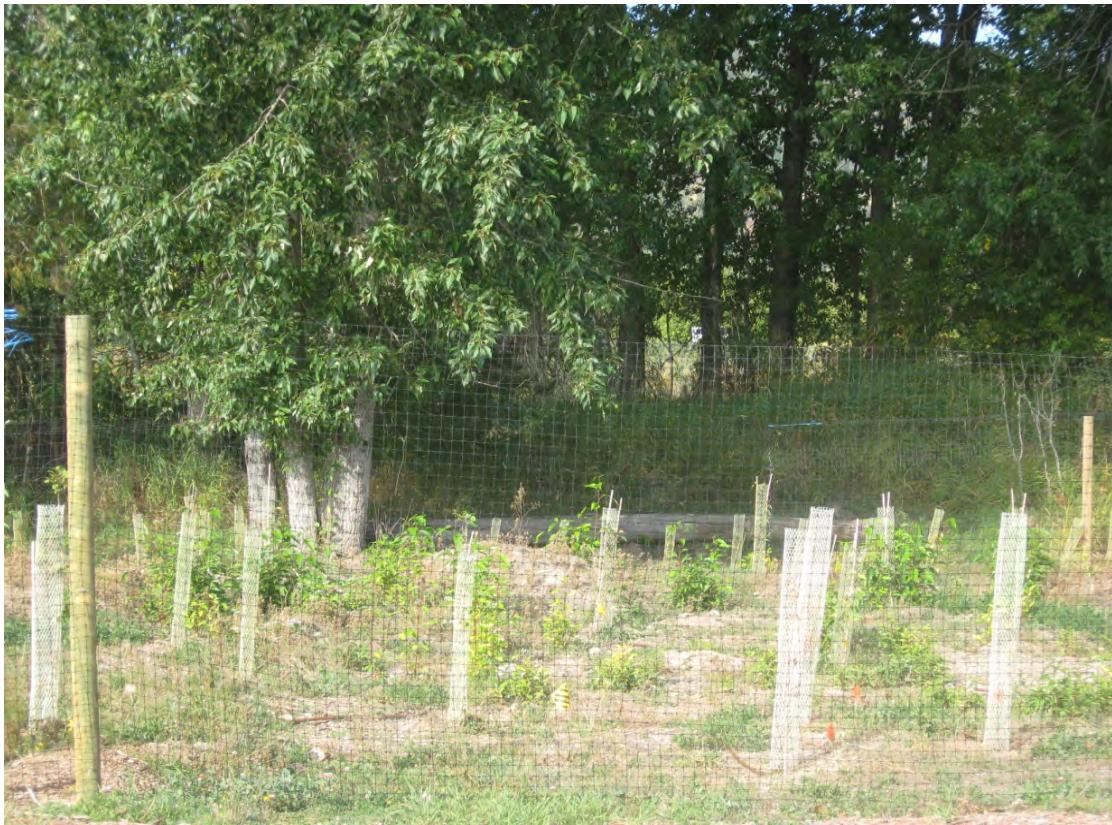
**Figure C-7. Comparison of volunteer cottonweed growth between July 2018, immediately pre-exclosure (top) and 6 weeks later in September 2018 (bottom) looking east at the first exclosure from the HW access road .**

Although heavily grazed by ungulates, the volunteer seedlings exhibited high vigor. To assist in meeting the long term native plant cover requirement, an exclosure was constructed in July around the area in which the greatest concentration of naturally establishing cottonwoods occurred. The exclosure extended from the HW access road to the unnamed stream channel (approximately 50 feet wide) and extended 110 feet along the road. More than 200 cottonwoods were tallied in the exclosure. The cottonwoods in the exclosure more than doubled in height within a 6-week time period (see Figures C-7 and C-8).

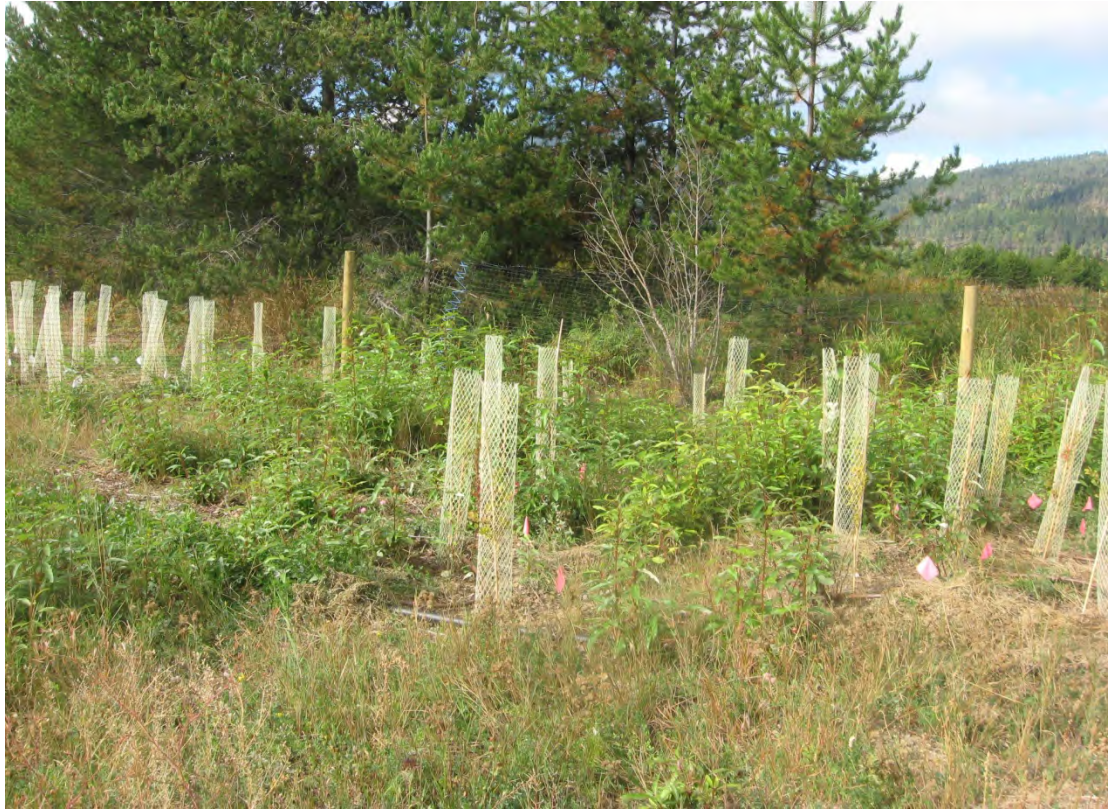
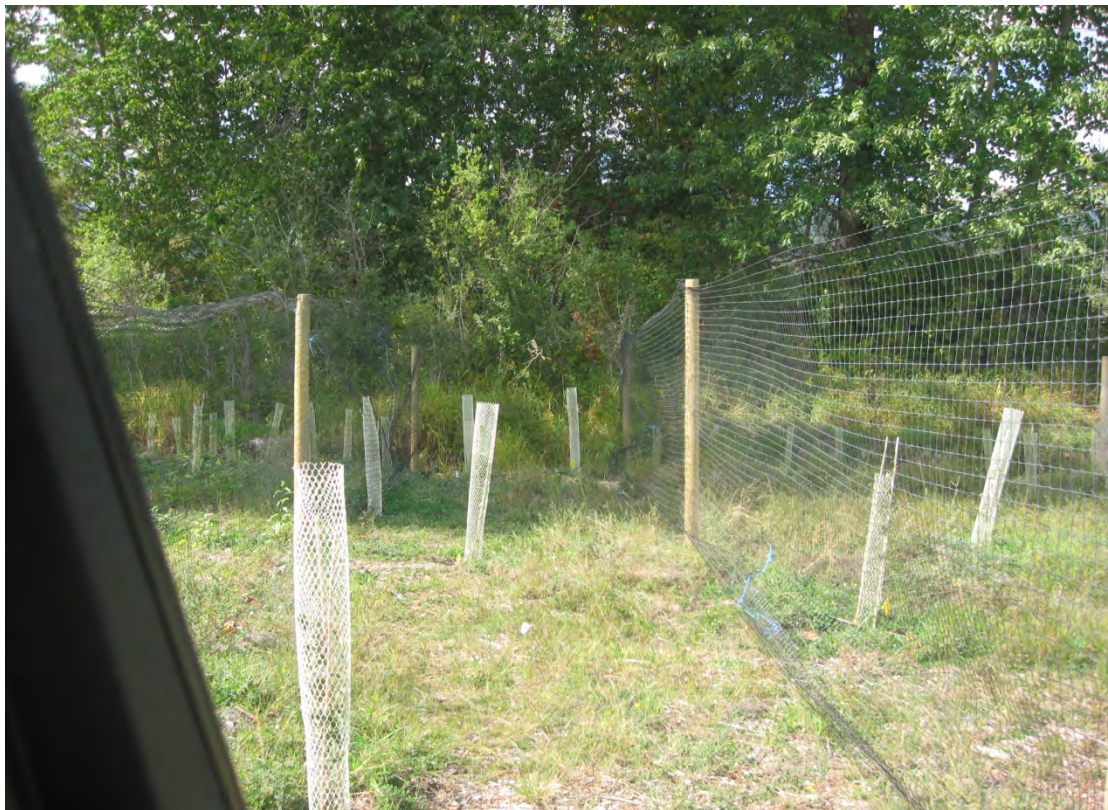
**Figure C-8. Close-up of volunteer cottonwood growth in enclosure 1 (top) and the narrow ungulate path to the larger riparian wetland between exclosures 1 and 2 (bottom).**

As a result of this success, two additional exclosures were constructed encompassing another estimated 300 cottonwood seedlings. The new exclosures were 125 and 74.5 feet long along the access road and also extended to the channel. Corridors were left between exclosures for ungulate passage to and from the heavily used HW Reference area. In addition to protecting the naturally establishing cottonwoods, all of the aspen (*Populus tremuloides*), 90% of the planted cottonwoods and most of the dogwoods (*Cornus sericea*) fell inside the exclosures. These taller plants had outgrown their anti-herbivory cages requiring new caging to protect against ungulate herbivory. In lieu of new individual plant cages, the existing cages were removed once plants within the exclosures entered dormancy.

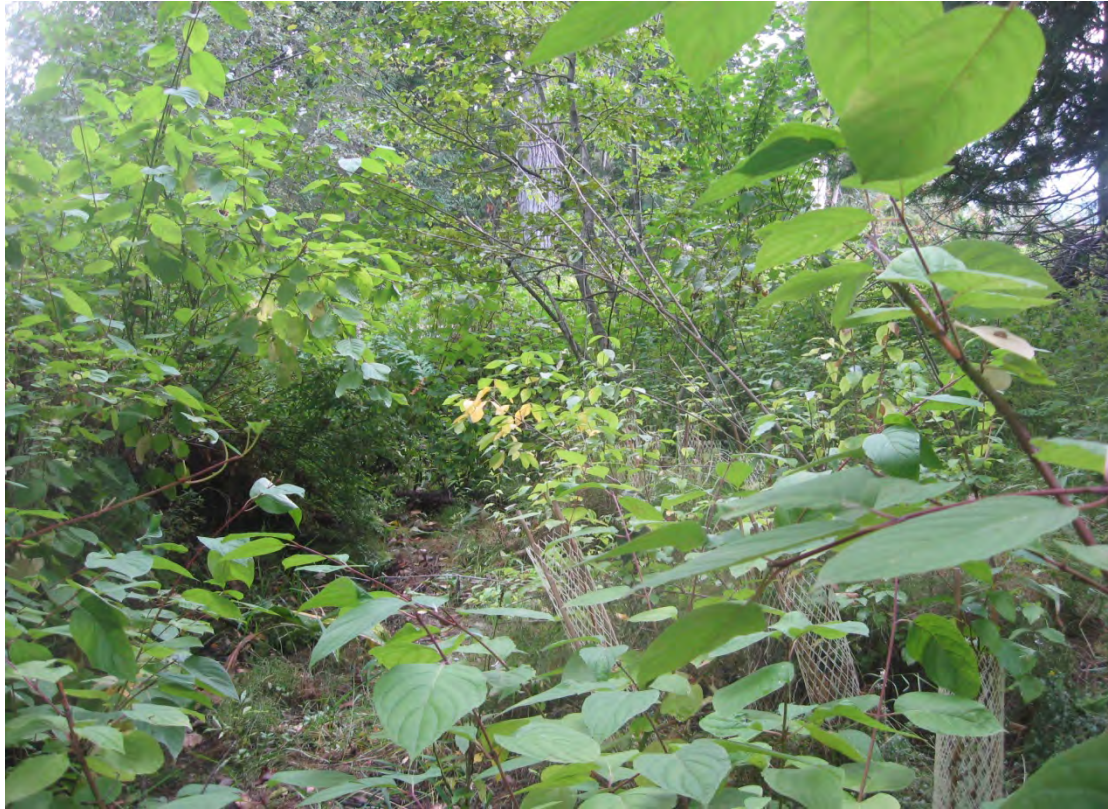
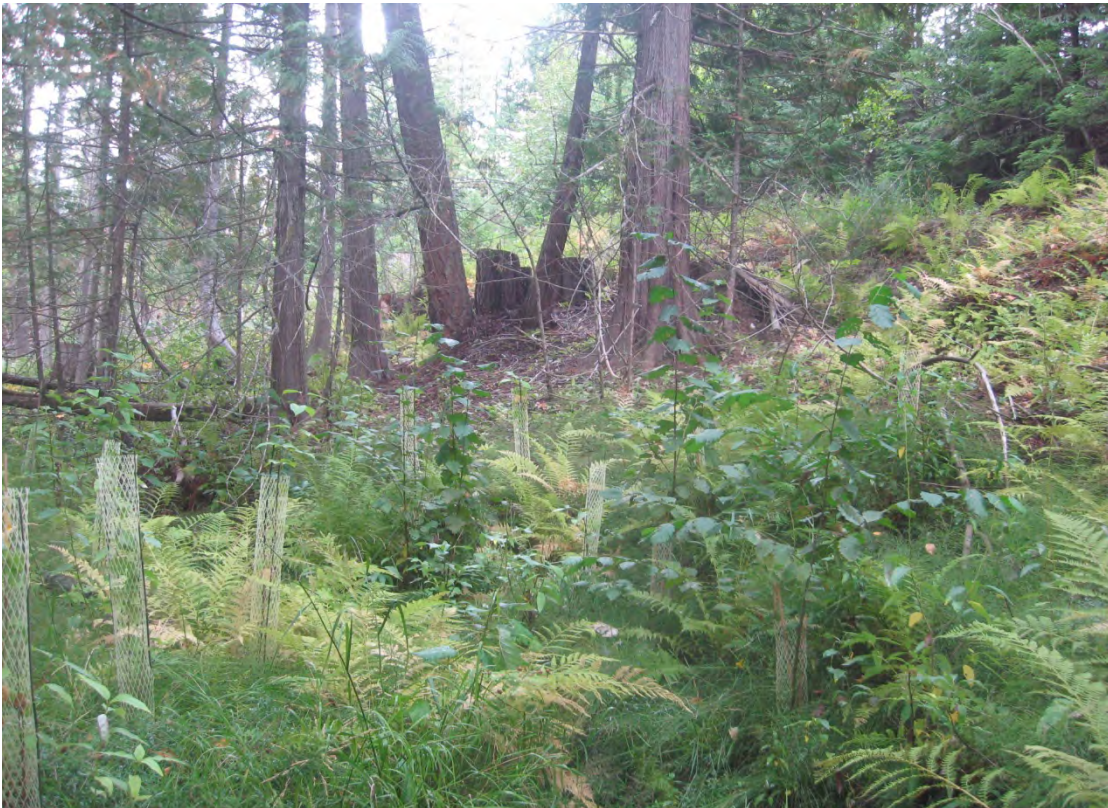
**Figure C-9. Culvert area shrub growth in September 2018 looking southwest (top) and east (bottom) from Culvert PP3.**

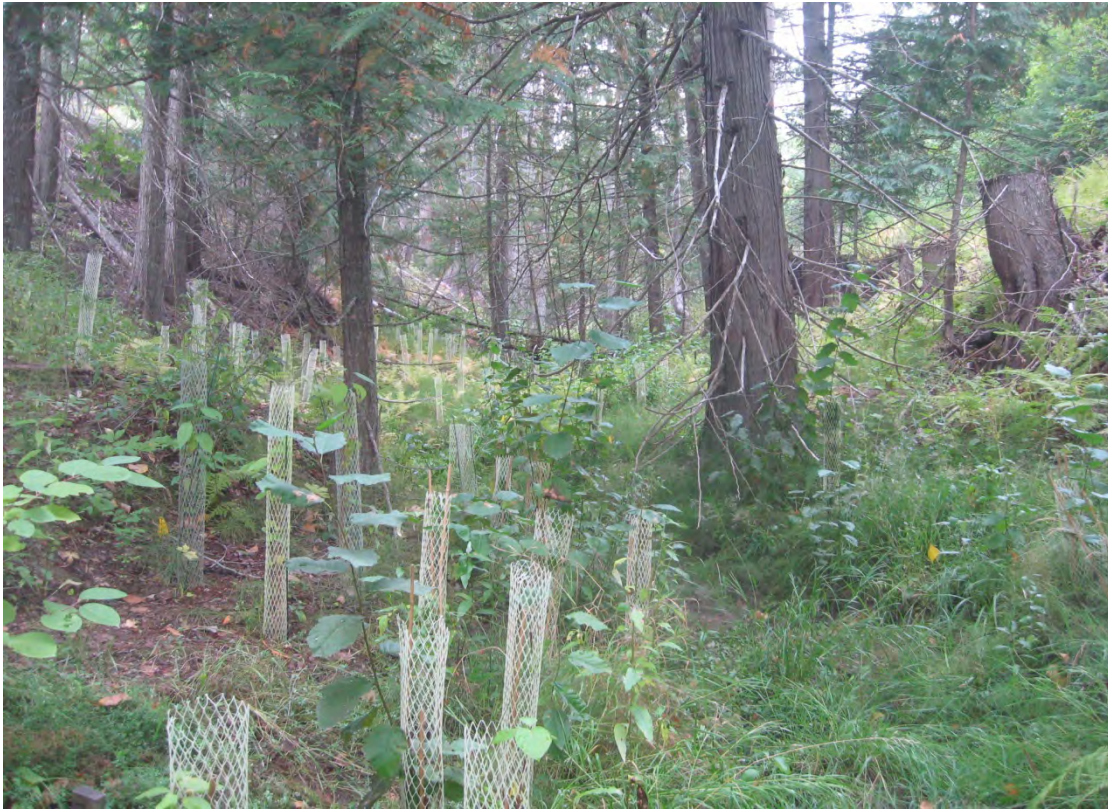
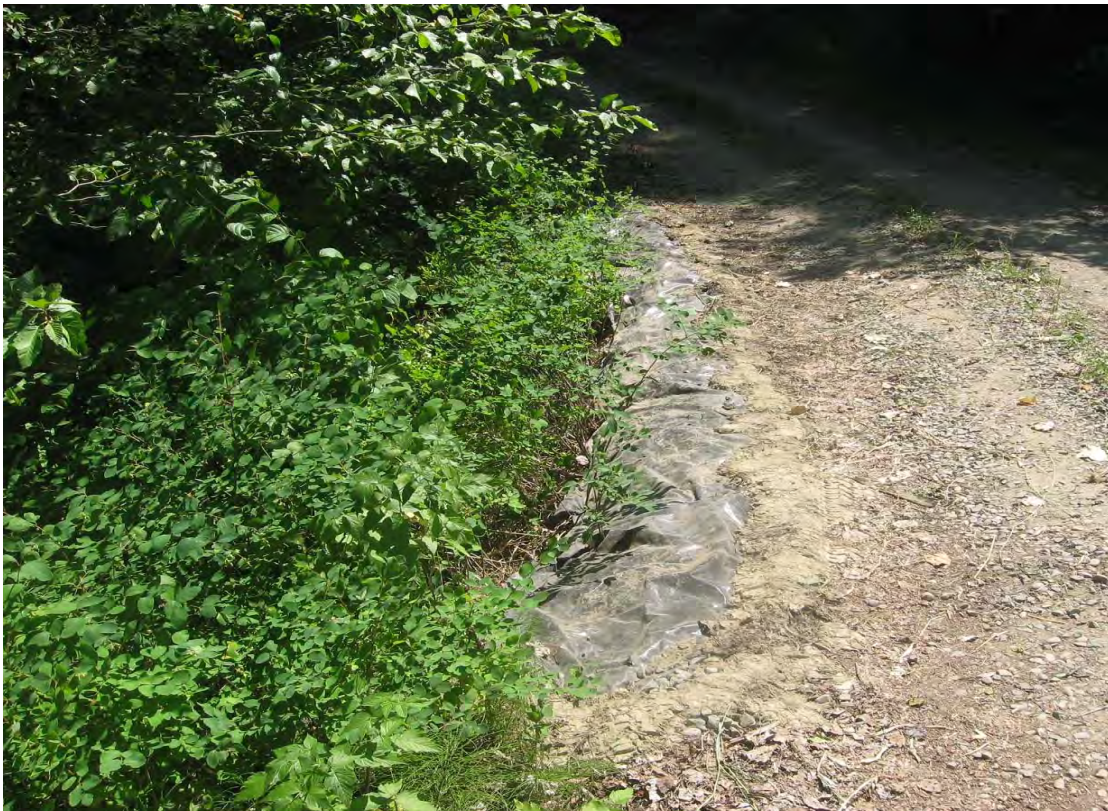
**Figure C-10. Culvert area shrub growth in September 2018 looking northeast from Culvert PP4, showing planted shrubs far outgrowing their cages (top) and at the RCG removal area with black plastic barrier to prevent future encroachment (bottom).**

There was some regrowth of RCG from the access road into the Culvert area. The RCG was removed manually during July and solarization material placed along the road to prevent the roadside RCG from continually growing into the mitigation area. No RCG remained following this treatment.

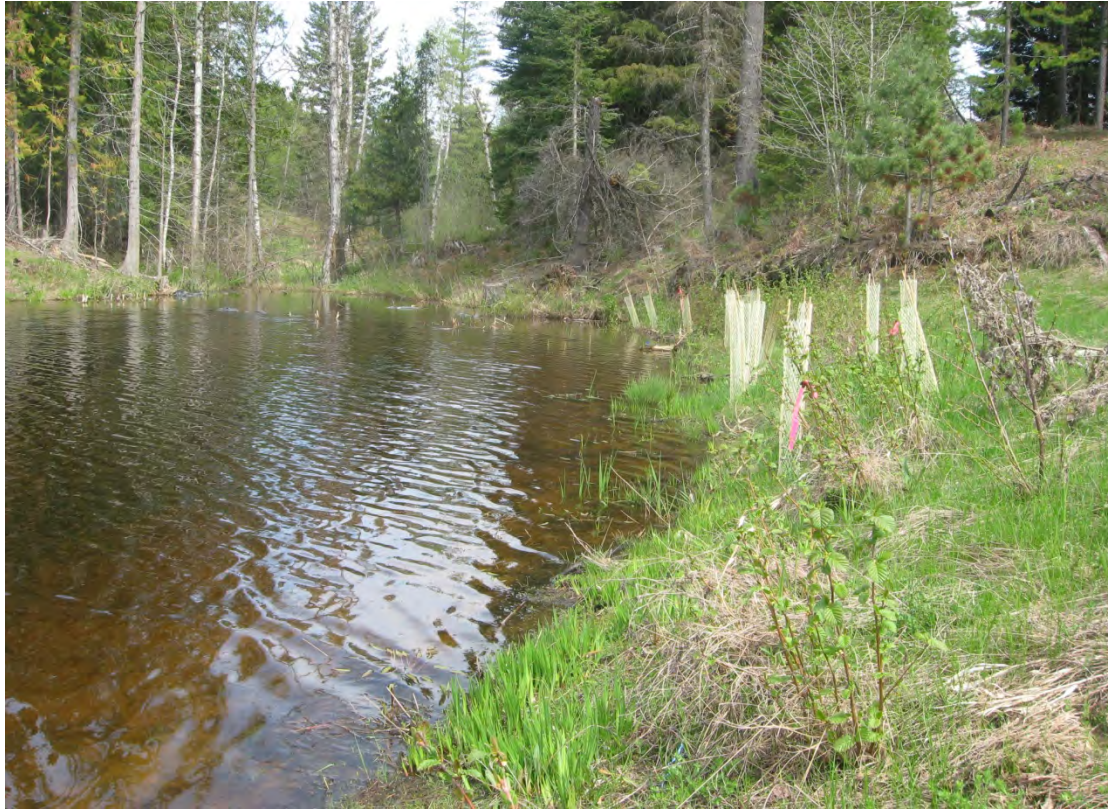
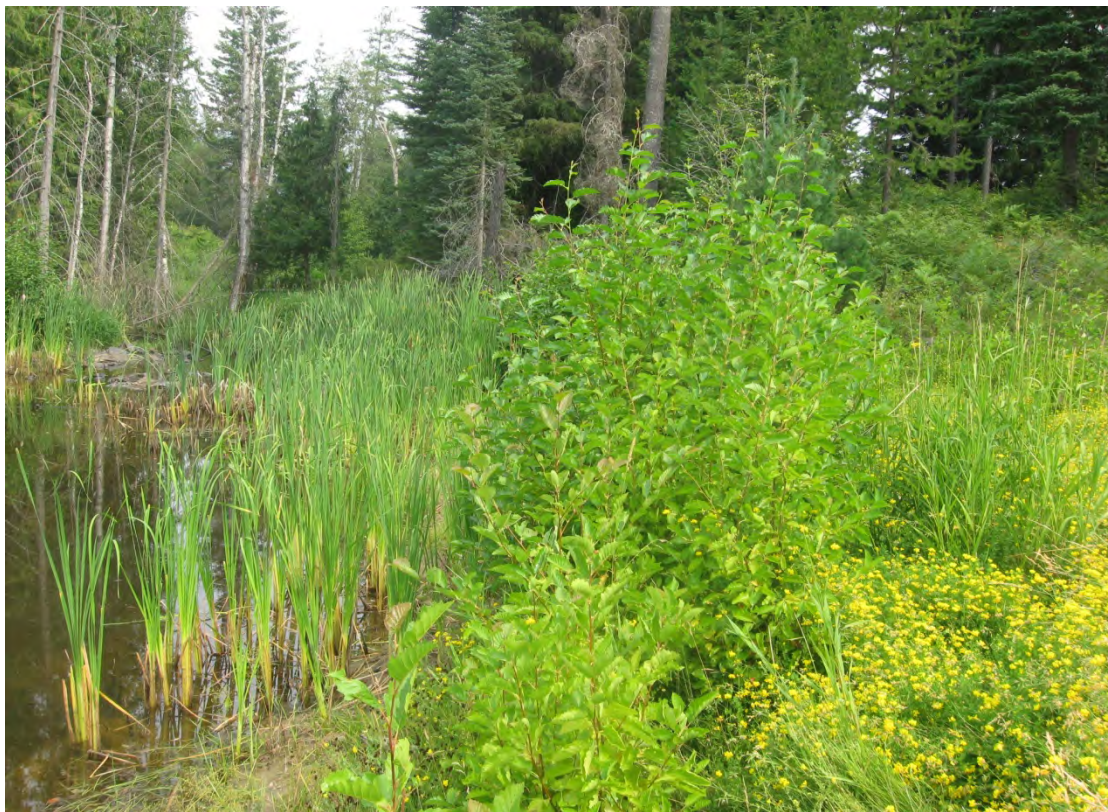
**Figure C-11. Upper Reservoir cover comparison between Spring 2017 (top) and Fall 2018 (bottom) looking north at PP5 .**

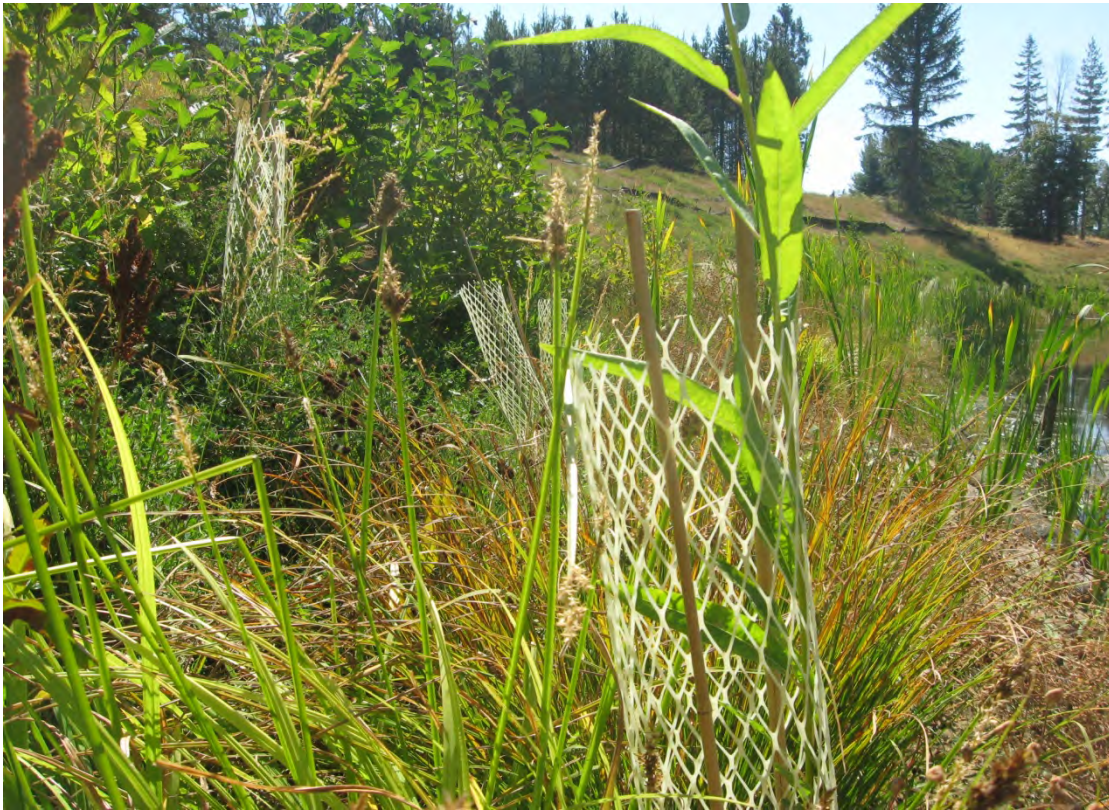
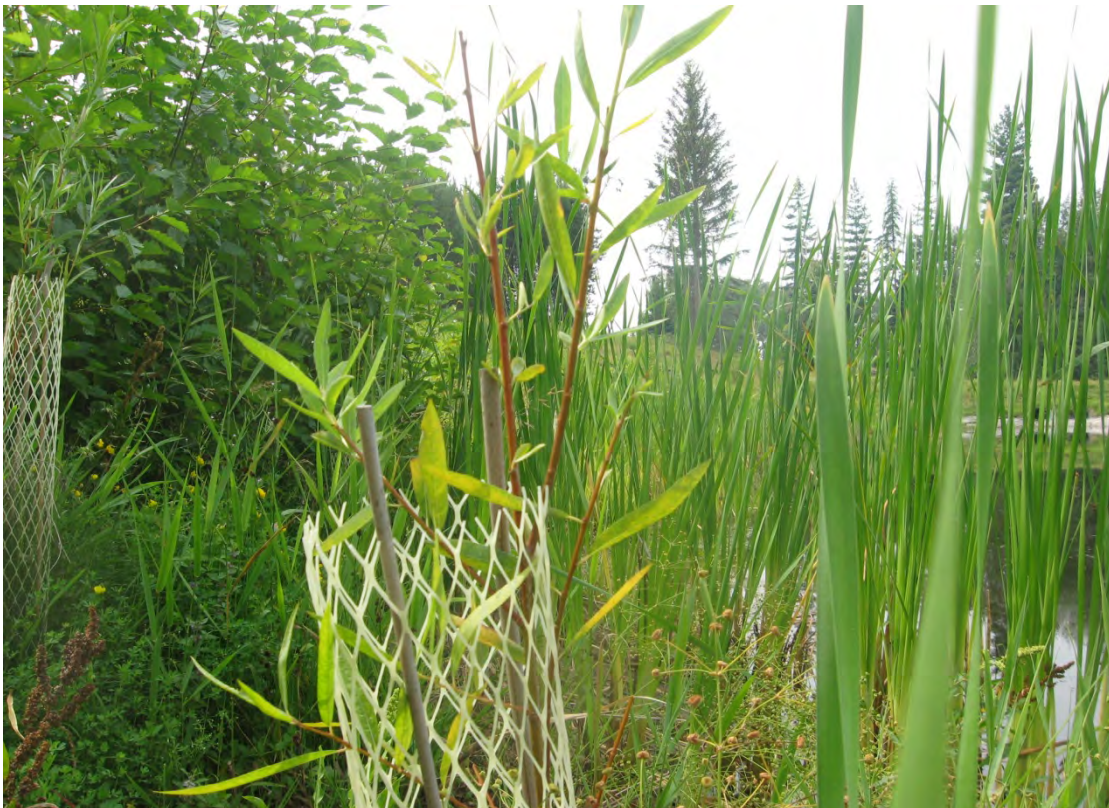
**Figure C-12. Reservoir cover looking south from PP5 in 2017 (top) and in 2018 (bottom) showing alder and cattail cover increase, and generally similar herbaceous cover but some species dominance change.**
